Geotechnical and mineralogical diagnostics of soil of residential settlements in Bannu

ABSTRACT

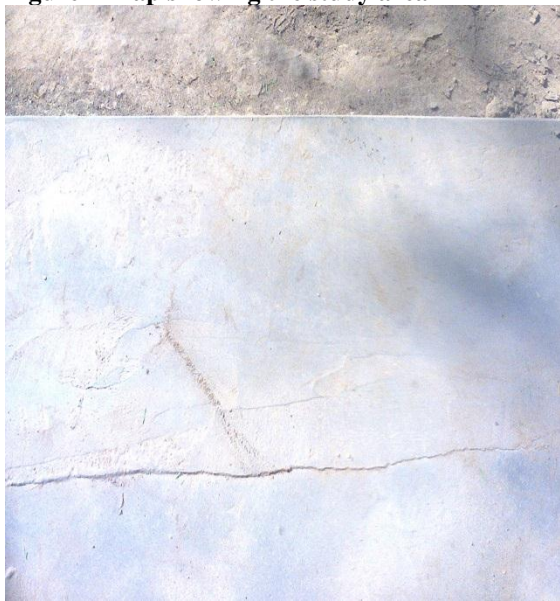
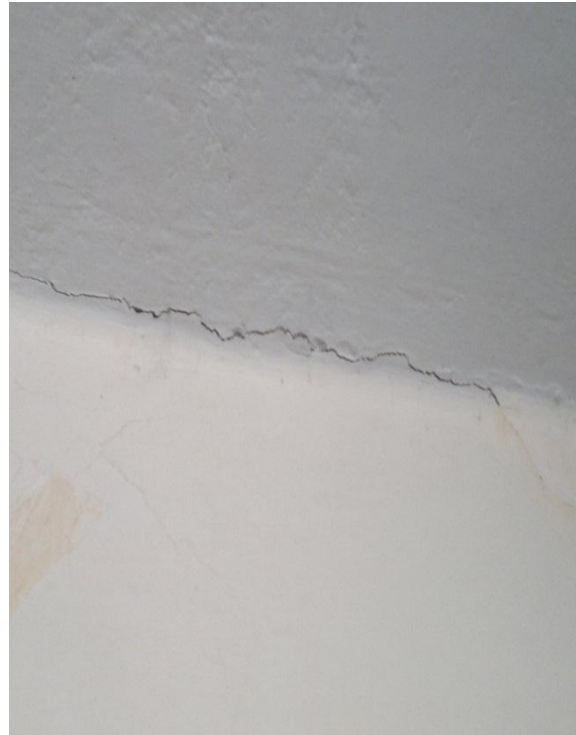
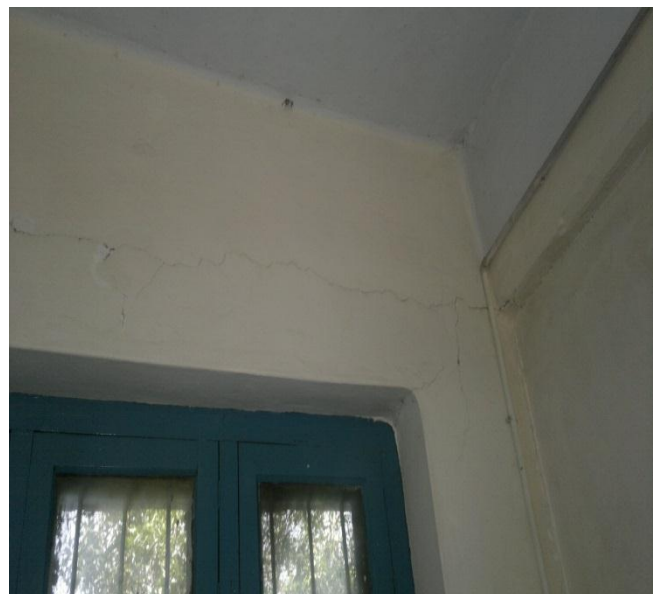
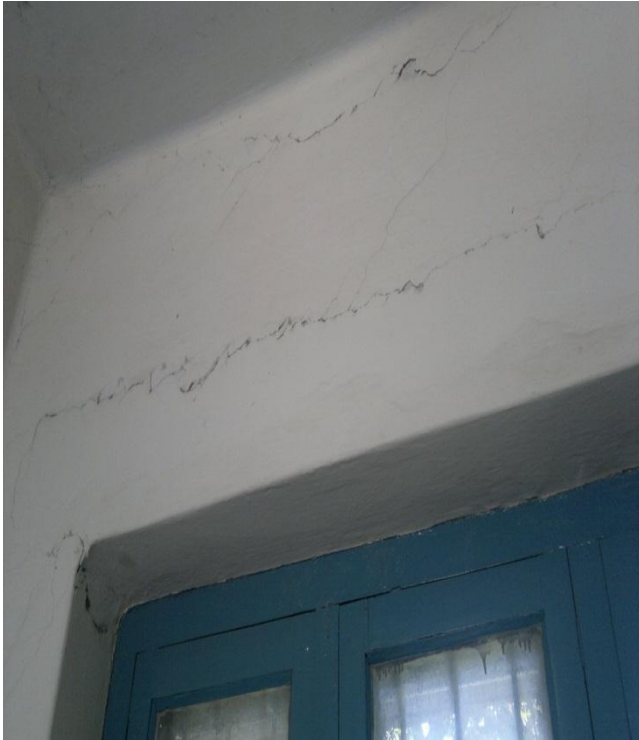
Fig-2 sample cracks appeared in the buildings

Facilities and it was found that the cracking of floors and boundary walls was very common occurrence in those areas, where houses were constructed mostly in agricultural lands. The irrigation was very frequent in these areas and drainage system was found to be very defective which led to the accumulation of rain water and its penetration into the ground. The migration of this water beneath the structures might be the reason for those cracks appearing in various parts of the houses.

When some people of the concerned areas were consulted, They admitted that the depth of foundation in these areas were not more than 3ft which comes in the range of active zone vulnerable to swelling hazard. This study was carried out to explore the fundamental reason behind all this. This is to prove whether the clay and non-clay minerals are present in this soil or not. For this purpose the trial pits were made in the regions marked by small circles in **Fig-1**, samples were recovered

In order to avoid the hazard of swelling of soils and protect the buildings and infrastructure from future damages, it is necessary to evaluate the soil in terms of its geotechnical properties first as the liquid limit and plasticity index may be the preliminary indicators of expansive soil and further if the clay fraction is more than 11%, the Danger of swelling may still be present (S N Abduljauwad 1994)

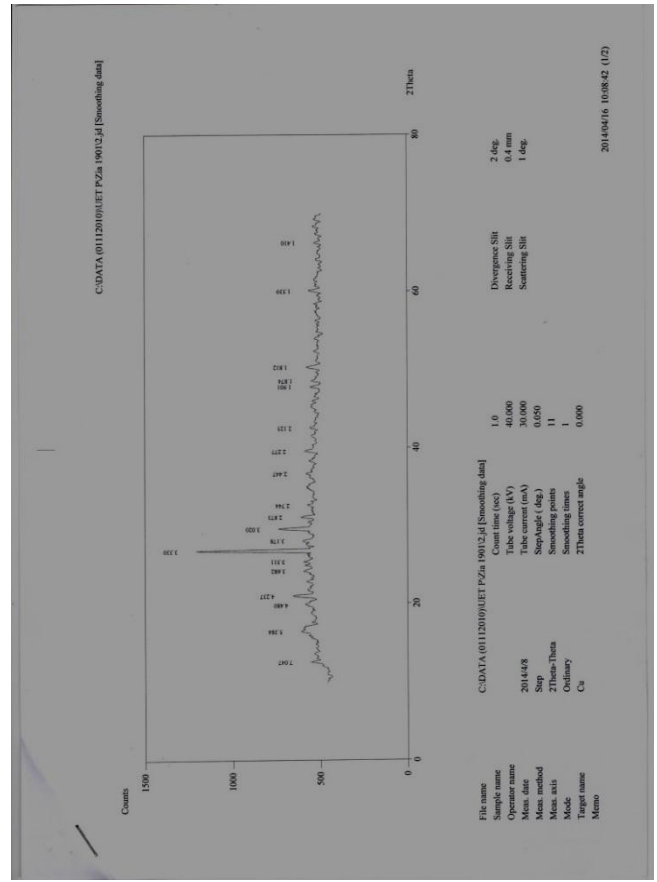
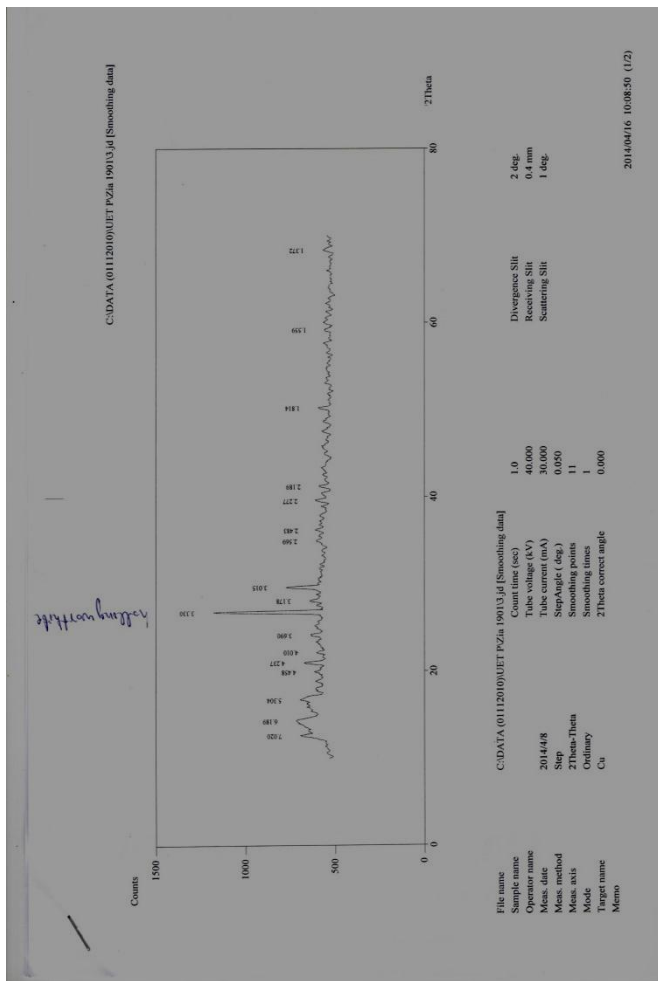
Fig3 XRD patterns for various samples (a) kala kalay (b) Doctor colony (c) small khoni (d) dat kala (courtesy centralized research lab, physics department, University of Peshawar)

Where λ wavelength and d is spacing between planes of crystal. Cu was used as a source of X-rays. Four Powdered samples were prepared from the soil obtained from Doctor Colony, kala kalay, small khoni and dat kaly and their diffractometer records have been shown in **fig-3**. It is quite obvious from the diffractometer records that all the samples are consistent in phase and peaks with each other and clearly indicate the absence of clay minerals responsible for absorption of moisture and causing heave because all these minerals lie in the range of very low values of 2θ ranging from 4 to 8 and yielding larger values of d-spacing from 14 up to 17 Å⁰ (Muawia.A.Dafella et al 2012). No such pattern can be observed in the peaks represented in **fig-3**. This is in accordance with the fact that the liquid limits of the soil samples are not more than 41. While in the presence of these clay minerals like smectite, montmorillonite and illite the soil samples yield liquid limits more than 50 and can be placed as CH or MH on the plasticity chart shown in **fig-5**
